FRC ON-SITE AIR BAG DEPLOYMENT INVESTIGATION

CASE NO. 90-13

FLEET - 1988 ACURA LEGEND

LOCATION - [REDACTED] NY

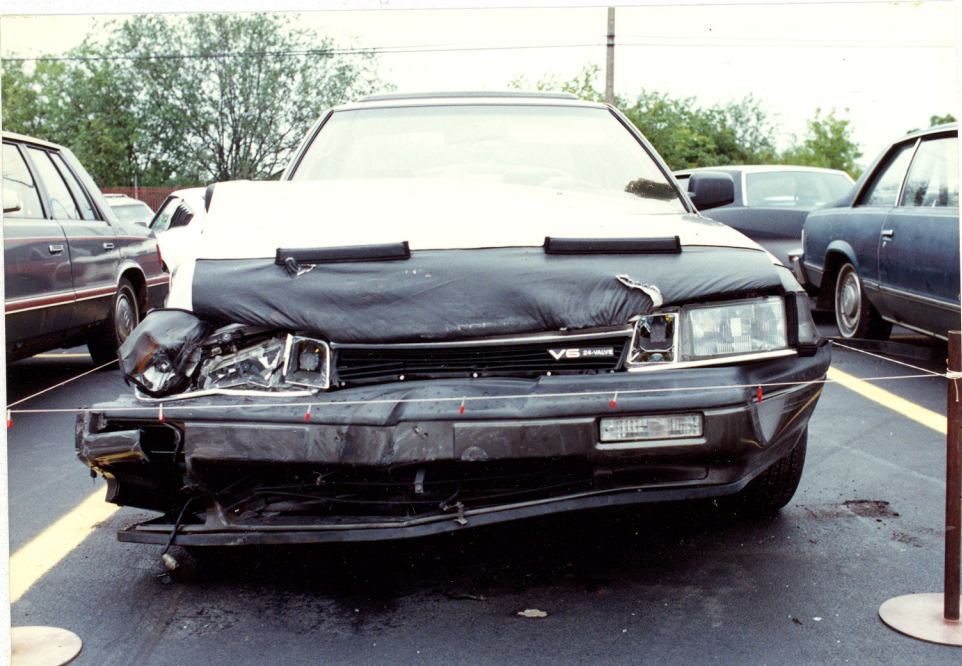
The frontal area of the Acura Legend impacted the right side of vehicle #2. Maximum crush was 15.5" located on the front bumper at the right corner. Direct contact damage was 62.5" in length and extended across the entire frontal plane. Crush values at bumper level were as follows: C₁=1.5", C₂=2.5", C₃=5.5", C₄=7.625", C₅=9.5", C₆=15.5".

Frontal View Of The Acura Legend.

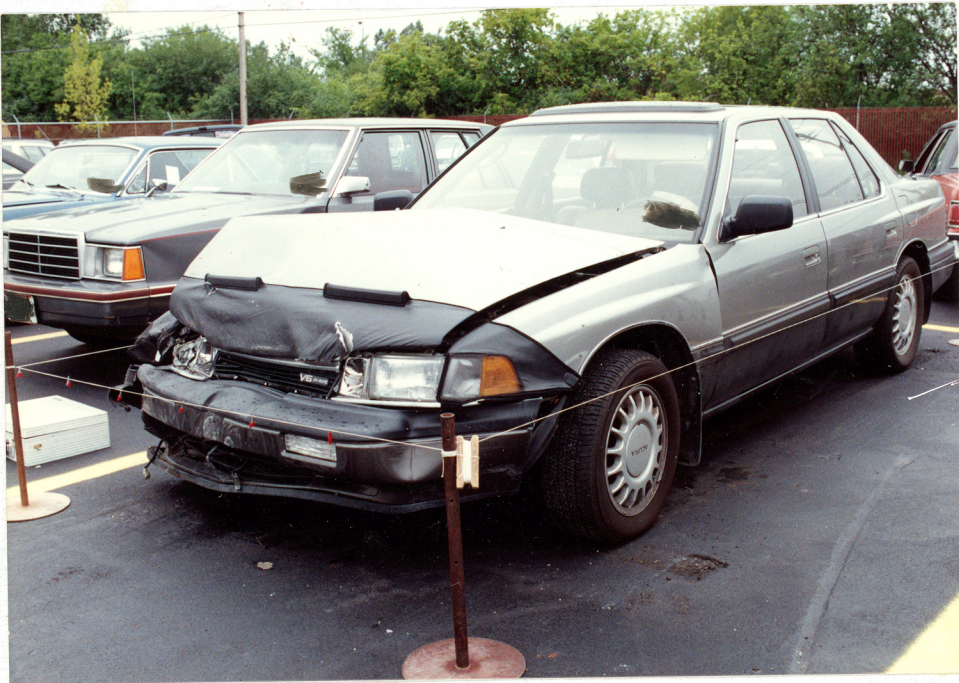
3.

Left Front Three-Quarter View.

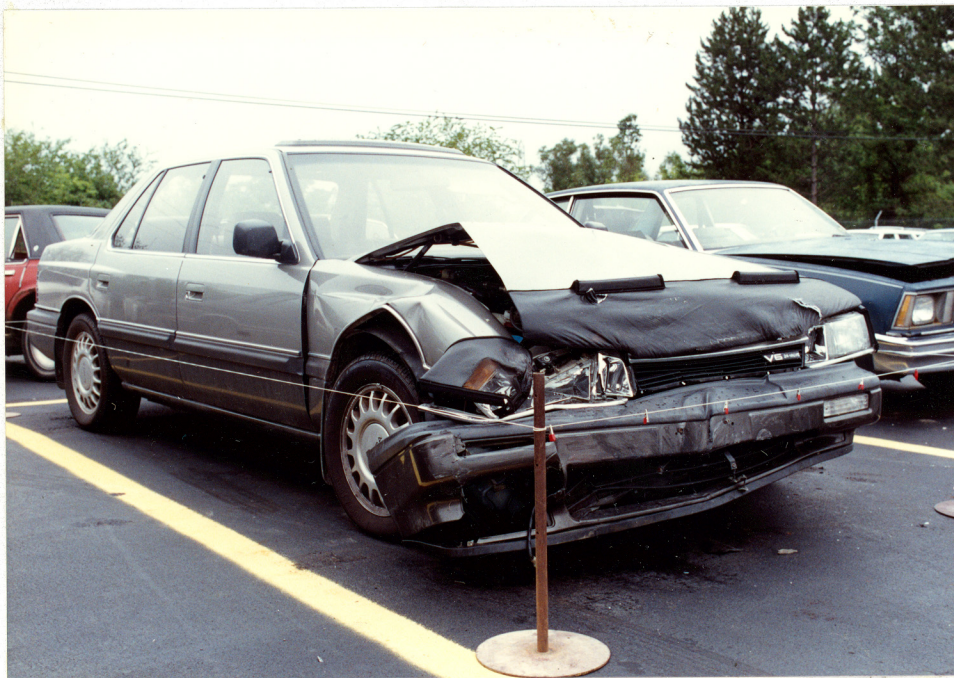
4.

Right Frontal Three-Quarter View.

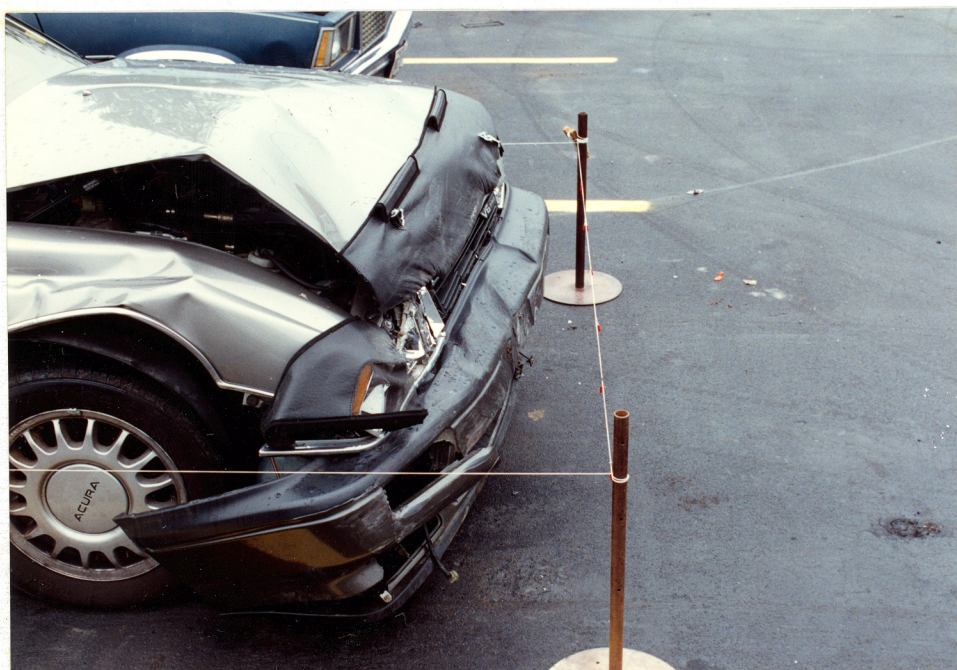
5.

Perpendicular View Of The Frontal Plane Showing The Extent Of Crush.

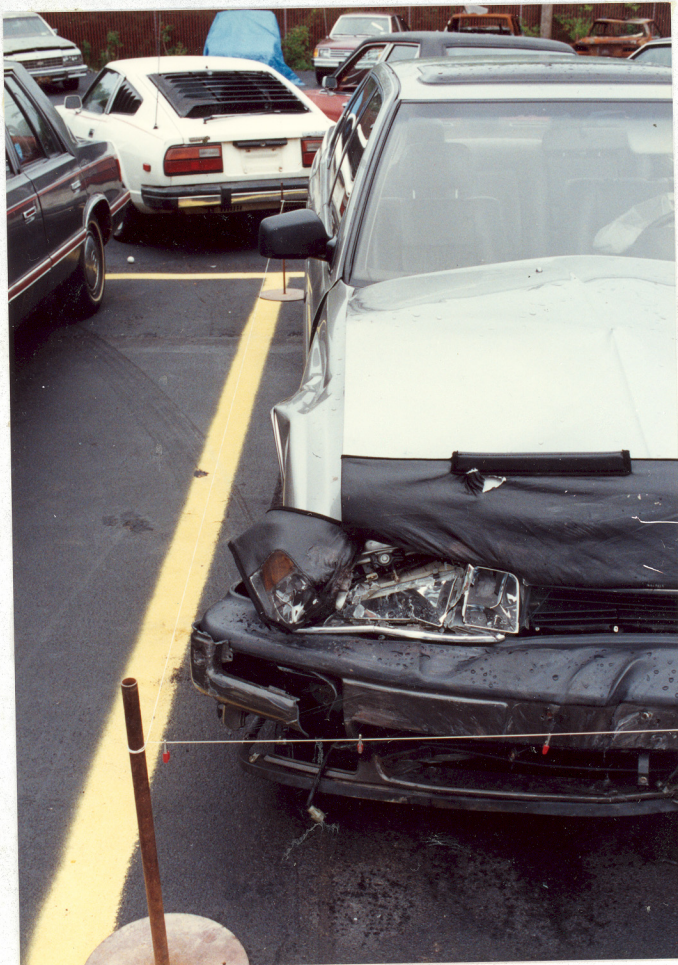
6.

Longitudinal View Showing The Lateral Displacement Of The Frontal Plane.

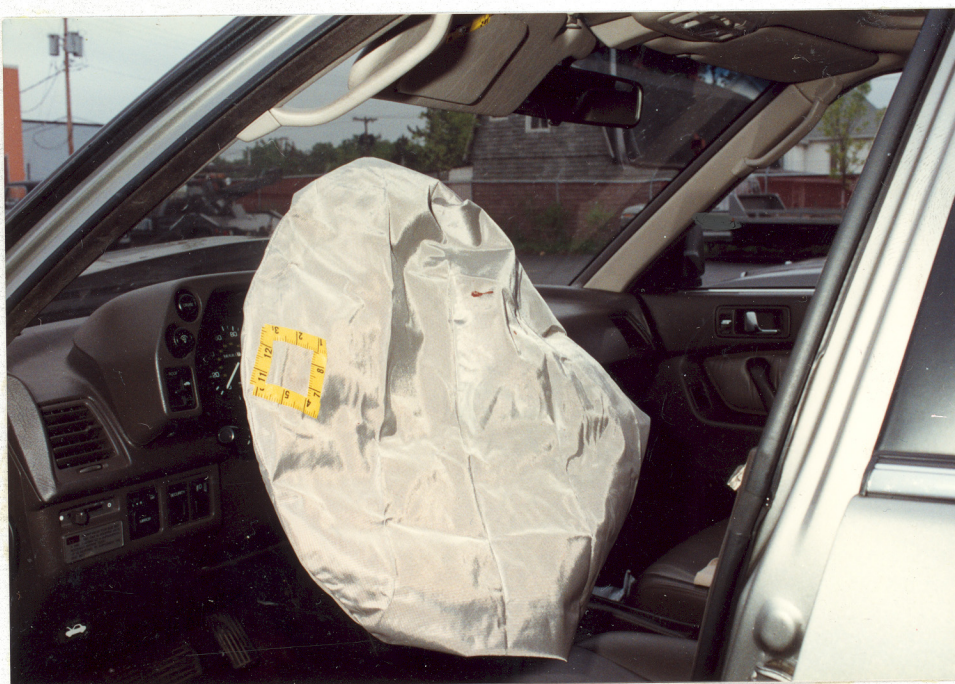
The Acura Legend was equipped with a driver air bag system that deployed as a result of the frontal impact sequence. The deployed air bag measured approximately 24" in diameter and was vented through two ports that were 1.25" in diameter located on the back (module) side of the air bag. The bag did not have an internal tether strap and was stitched together with an internal seam. There were no tears or apparent flaws in the bag material.

Overall Interior View And The Deployed Air Bag.

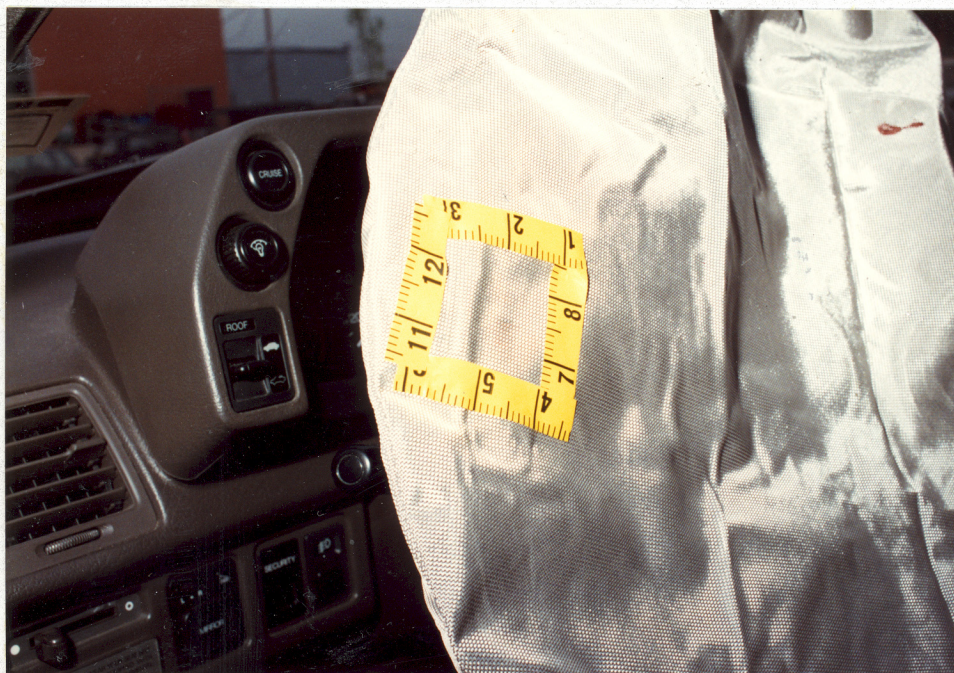
The interior of the Acura Legend was not damaged or reduced in size by component intrusion. The driver loaded the deployed air bag and deposited a make-up transfer (1" in diameter) 9" above the horizontal centerline of the bag and 1.5" left of the vertical centerline. Blood stains were also noted to the right lower quadrant of the bag.

Driver Facial Contact (Makeup Transfer) To The Left Upper Quadrant
The Air Bag.
